## the *dynamic* offshore engineering company

### DISPOSABLE CAMERA SYSTEM – CASE STUDY

Newfield were planning to run a Dril Quip Subsea Tree complete with an Overtravelable Protective Structure as part of their Grove development.

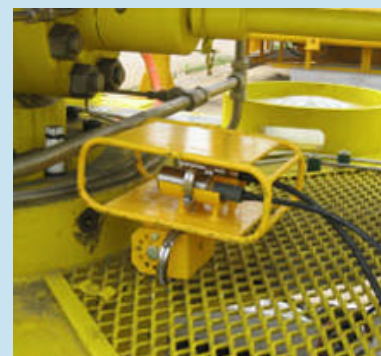
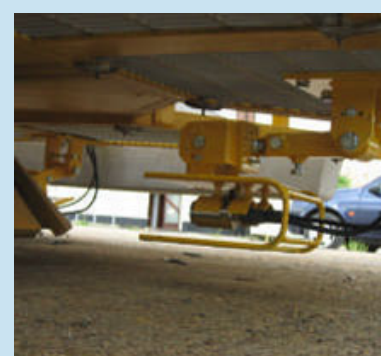
Brackets positioning the cameras  
a) Camera 4 witnessing the hydraulic locking pin and b) Camera 2 beneath the structure

Camera 2 – positioned at 90 degrees to camera one looking straight across the base of the capture cone to confirm land out point and assist with capture.

Camera 4 – positioned to enable a clear and consistent view of the hydraulic locking pin which was difficult for the ROV to access.

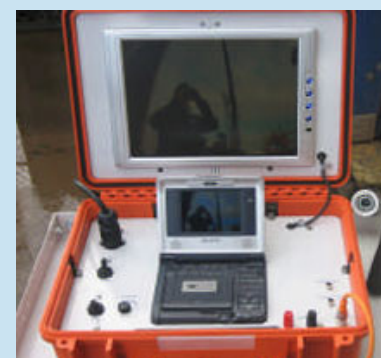
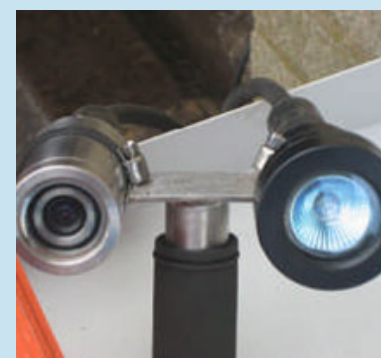
c) Surface control unit and  
d) Close up of camera and light unit

- Cameras connected to a subsea junction box and the signal relayed to surface via and umbilical attached to the drillstring.
- Real time pictures viewed on master control unit, with facility to record and switch between camera views. Still captured from the video footage are shown over the page.

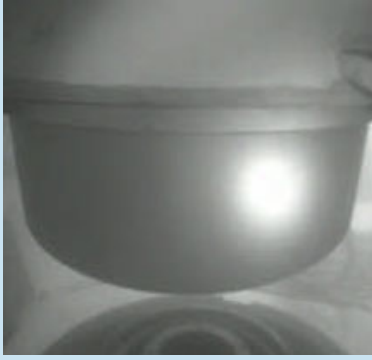
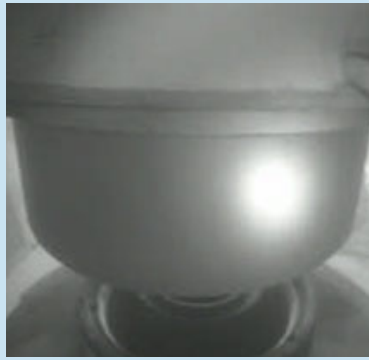
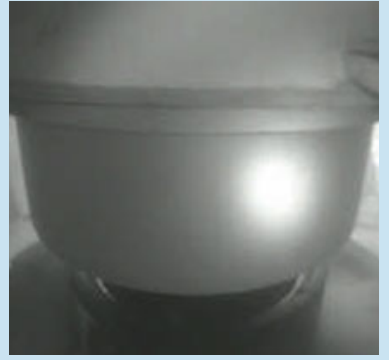
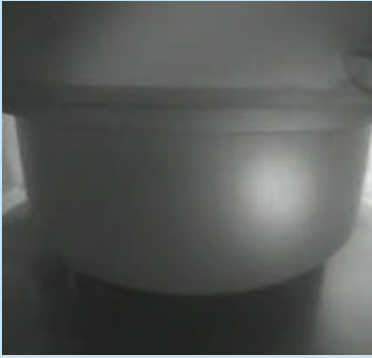
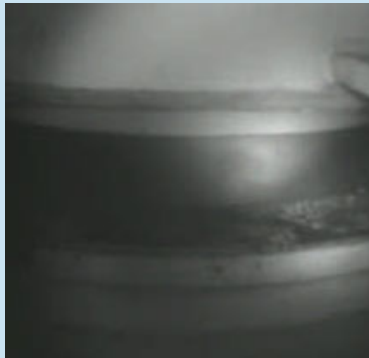
Camera 3 showing the capture of the well stub by the subsea tree.

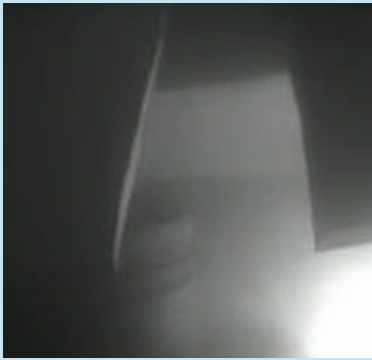
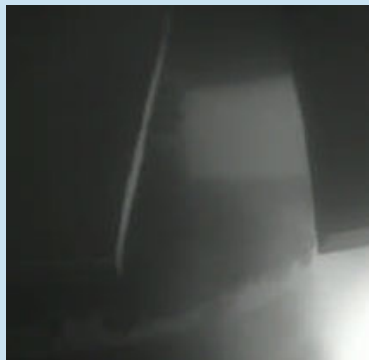
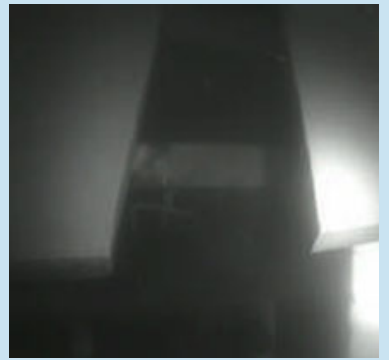
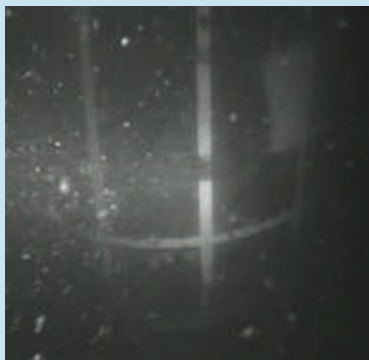
Camera 2 showing the capture of the well stub , final picture shows camera angled down

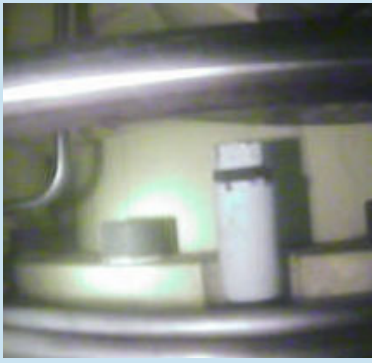
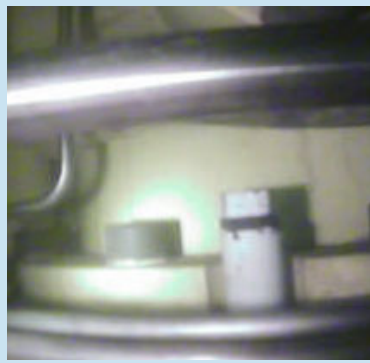
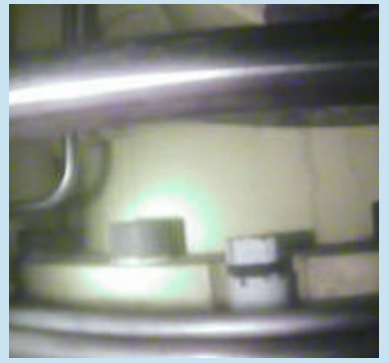
Camera 4 showing locking of subsea tree via downward movement of the indicator pin.
